# Conservation and analytical study of metallic elements from medieval Spanish stained glass windows

M. García-Heras<sup>1</sup>, M.A. Villegas<sup>1</sup>, E. Cano<sup>1</sup>, And J.M. Bastidas<sup>1</sup>; F. Cortés<sup>2</sup>  
Julio 2003

## Abstract

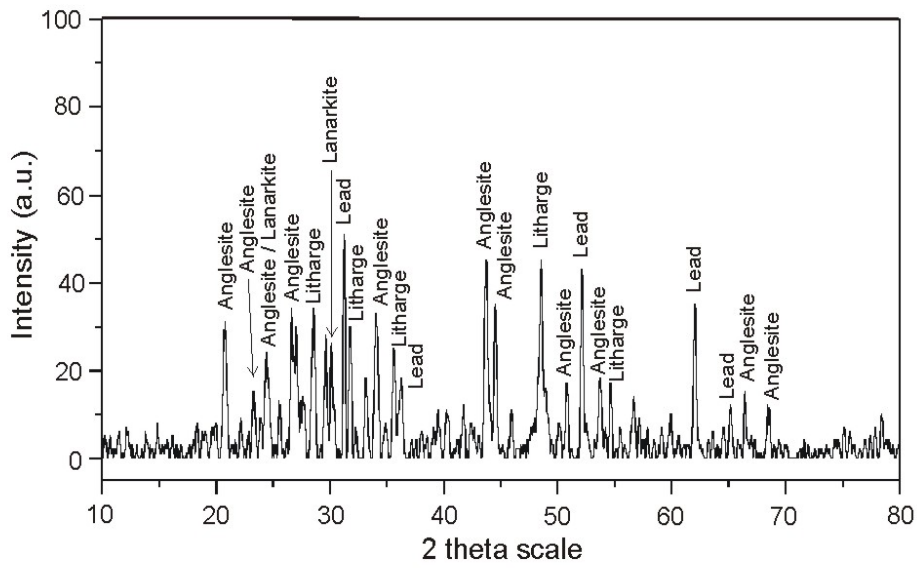
Fig. 4. X-ray diffractogram of a corrosion products layer from a lead came sample.

Four phases have been identified by XRD analysis (Fig. 4) on lead corrosion products: anglesite ( $\text{PbSO}_4$ ), lanarkite ( $\text{Pb}_2\text{O} \cdot \text{SO}_4$ ), litharge ( $\text{PbO}$ ), and metallic lead (Pb), probably dragged away from the specimen during sample preparation. These corrosion products are typical of lead exposed to an urban environment. The first step of atmospheric lead corrosion is the reaction with oxygen to form highly adherent lead oxides; then lead oxides form basic lead carbonates by reaction with atmospheric gases as

CO<sub>2</sub>. These compounds usually form a very adherent and protective layer which hinders further corrosion of the metallic substrate. However, in urban or industrial atmospheres, with a high concentration of SO<sub>2</sub>, this pollutant reacts with the carbonates, displacing CO<sub>3</sub><sup>=</sup> ions by SO<sub>4</sub><sup>=</sup> ions, and forming lead sulphates [15-17]. Lead sulphates are also very stable and protective.

An overall evaluation of the conservation state of the lead comes indicates a slight degree of corrosion, since corrosion layers observed are rather thin (30-40 μm) and the corrosion products formed play a protective role against further corrosion of lead bodies, as previous studies have shown [15, 16].

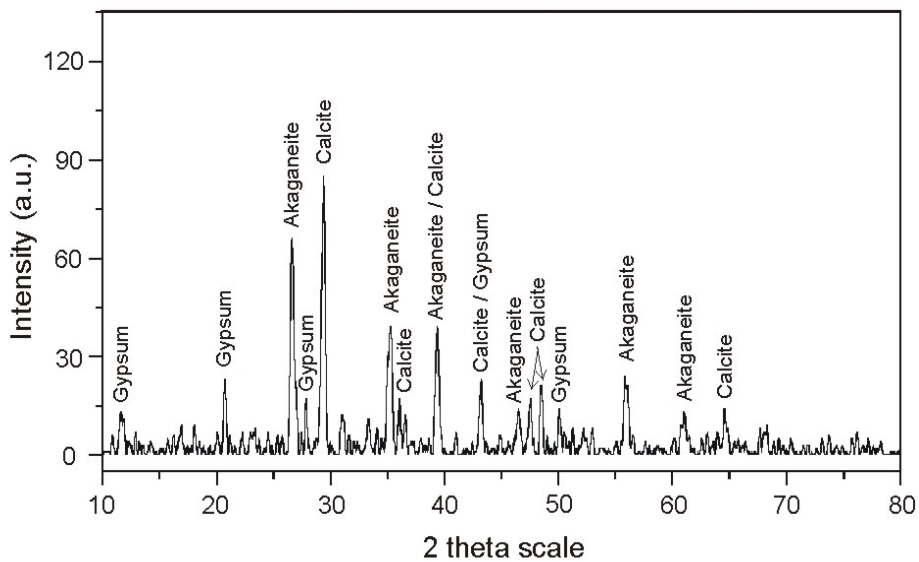
Fig. 6. X-ray diffractogram of corrosion products formed on the iron framework supporting samples.

XRD analysis undertaken on the iron corrosion products (figure 6) determined that they were composed of three different phases showing, as lead corrosion ones, a low degree of crystallinity. Phases detected were akaganeite [FeO(OH)], an iron hydroxide; calcite (CaCO<sub>3</sub>), and gypsum (CaSO<sub>4</sub>·2H<sub>2</sub>O). The presence of calcite could be attributed to either putty or mortar remains, while gypsum could be incorporated into the original putty or later formed from calcite as a consequence of its reaction with atmospheric SO<sub>2</sub>.

The presence of akaganeite ( $\beta$ -FeO·OH) instead of goethite ( $\alpha$ -FeO·OH) is a common feature of corrosion products formed on iron in chloride-rich environments. It is usually found in some irons coming from underwater archaeological findings. Akaganeite has a hollandite-type structure containing water and small amounts of chloride (about 2 wt. %). Such chloride ions stabilize the crystal lattice and cannot be removed by washing [18]. The occurrence of akaganeite is in agreement with the important amount of chloride determined through EDX microanalyses for both the fresh weathered surfaces and the cross sections. It has been proposed that the ratio Cl-/OH- is the main factor in formation of one hydroxide or another. Thus, for a ratio  $\leq 6$  only goethite is formed, while for a ratio  $\geq 8$  akaganeite is the only compound originated. In addition, both phases appear at intermediate values [19].

The presence of akaganeite is quite surprising, since important amounts of chlorine are necessary to form this compound. Seville is more than 60 km far from the sea, and therefore marine aerosols cannot be responsible for the deposition of such amount of chlorine. An explanation to the source of chlorine could be the town's harbour, which was located in the river and nearby the Cathedral. One of its quays is called the Salt Quay (Muelle de la Sal), which had an outstanding trade activity on this product (NaCl) in the past; the winds coming from this area in the river could therefore transport important amounts of salt aerosols, which were deposited on the iron elements of the nearby cathedral.

Akaganeite may pose serious difficulties for conservation of iron elements. On the one hand, it presents a higher volume than ordinary rust, which may produce mechanical damage of iron pieces. On the other hand, and under certain conditions, it could be transformed into hematite, releasing chloride ions that may continue corrosion of the metallic substrate [20].
